Manhole Inspection Summary

Manhole # S57M__017MH

Insp Date: **7/3/08 9:58 AM**

Location Address: **rear 3919 hudson st**

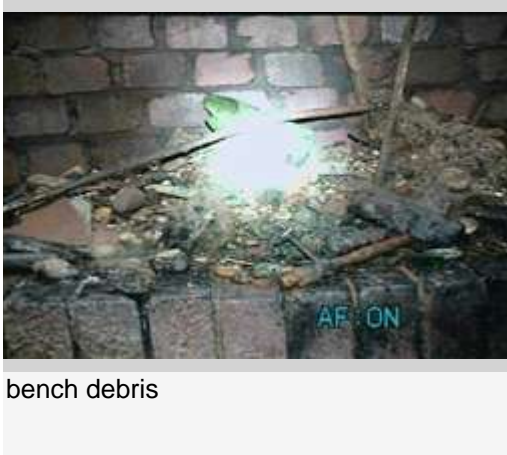
Defect 3

Condition: ☐ Sound ☐ Cracked ☐ Root Intrusion ☐ Deteriorated ☐ Leaks ☒ Debris

bench debris

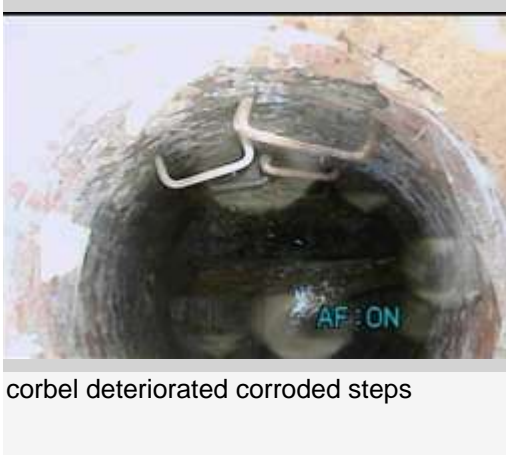
Defect 2

Condition: ☐ Sound ☐ Cracked ☐ Root Intrusion ☒ Loose Brick ☒ Deteriorated

Steps Count: **5** Missing: **0** ☒ Corroded

corbel deteriorated corroded steps

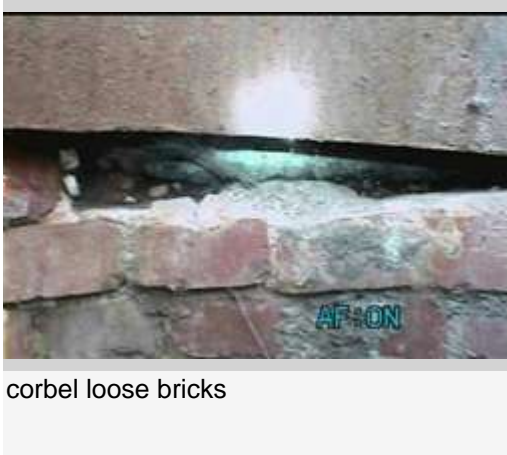
Defect 1

corbel loose bricks

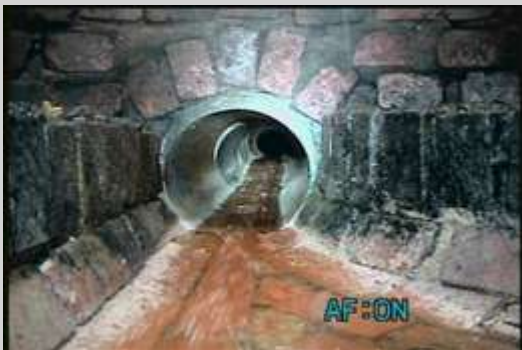
12 O'Clock Outflow

8 in. Circular Gravity Sewer
Pipe Out @ 12 O'Clock

Pipe Material: **Clay** ☐ Pipe Lined

Invert Depth: **9.86** (ft.) Flow Characteristics: **Fast**

Infiltration: **None** Pipe Seal Cond: **Unknown**

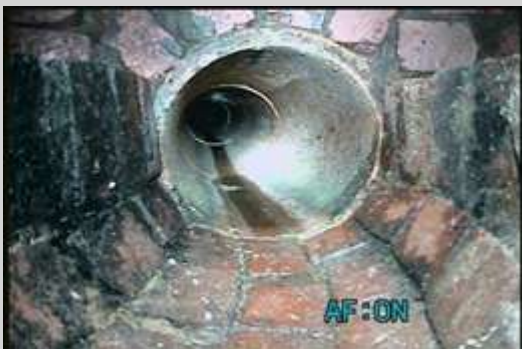
3 O'Clock Inflow

8 in. Circular Gravity Sewer
Pipe In @ 3 O'Clock

Pipe Material: **Clay** ☐ Pipe Lined

Invert Depth: **9.75** (ft.) Flow Characteristics: **None**

Infiltration: **None** Pipe Seal Cond: **Unknown**

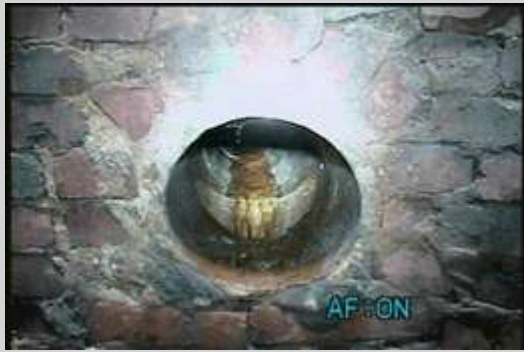
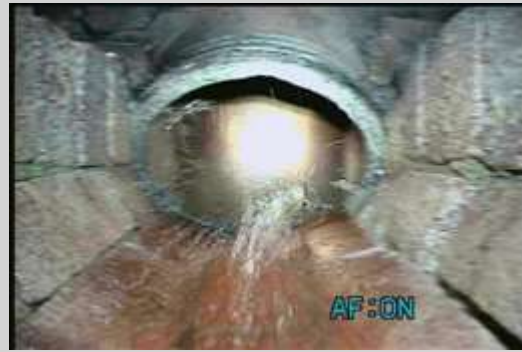
6 O'Clock Inflow

Pipe In @ 6 O'Clock

Drop In @ 6 O'Clock

Drop: **Outside Direct**

Drop Condition: **Open**
